US Army Corps  
of Engineers  
Construction Engineering  
Research Laboratories

USACERL Technical Report 99/25  
SFIM-AEC-ET-CR-98009  
February 1999

# Evaluation of Two Washrack Recycle Treatment Systems

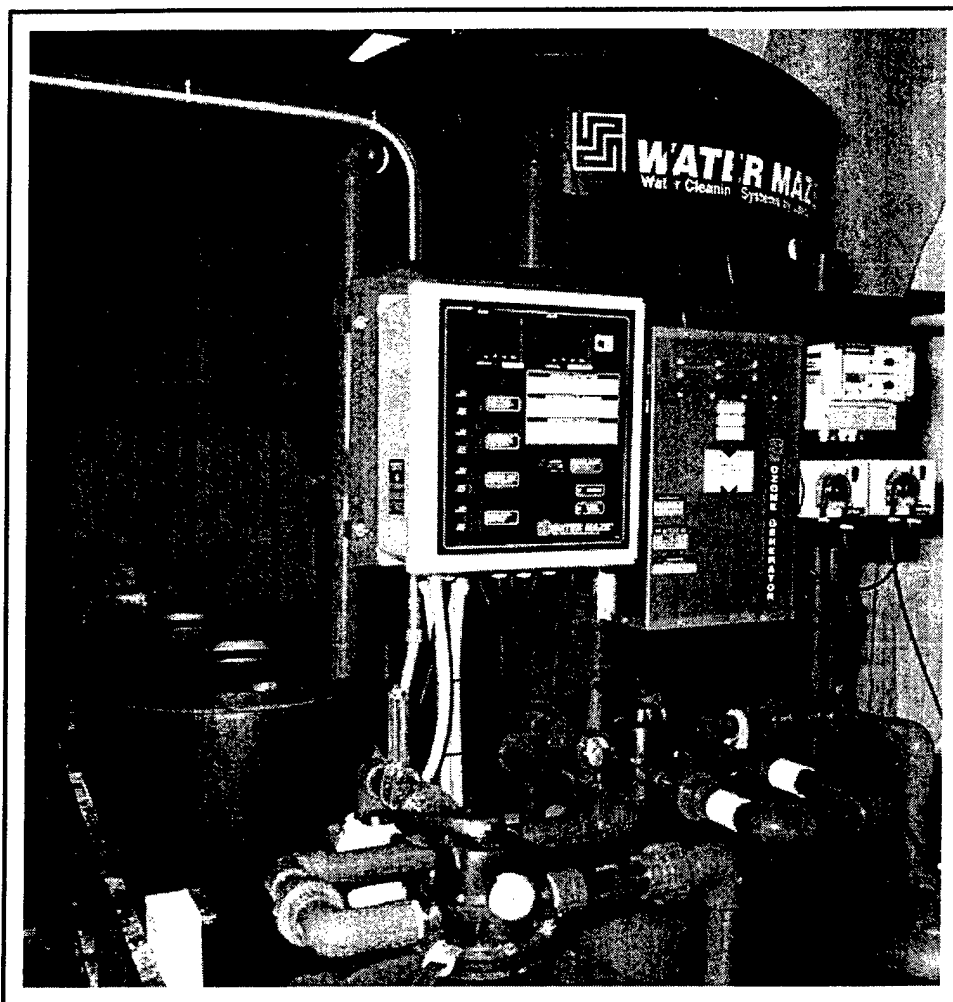
Figure 1. Landa system in Building 338, Aberdeen Test Center.

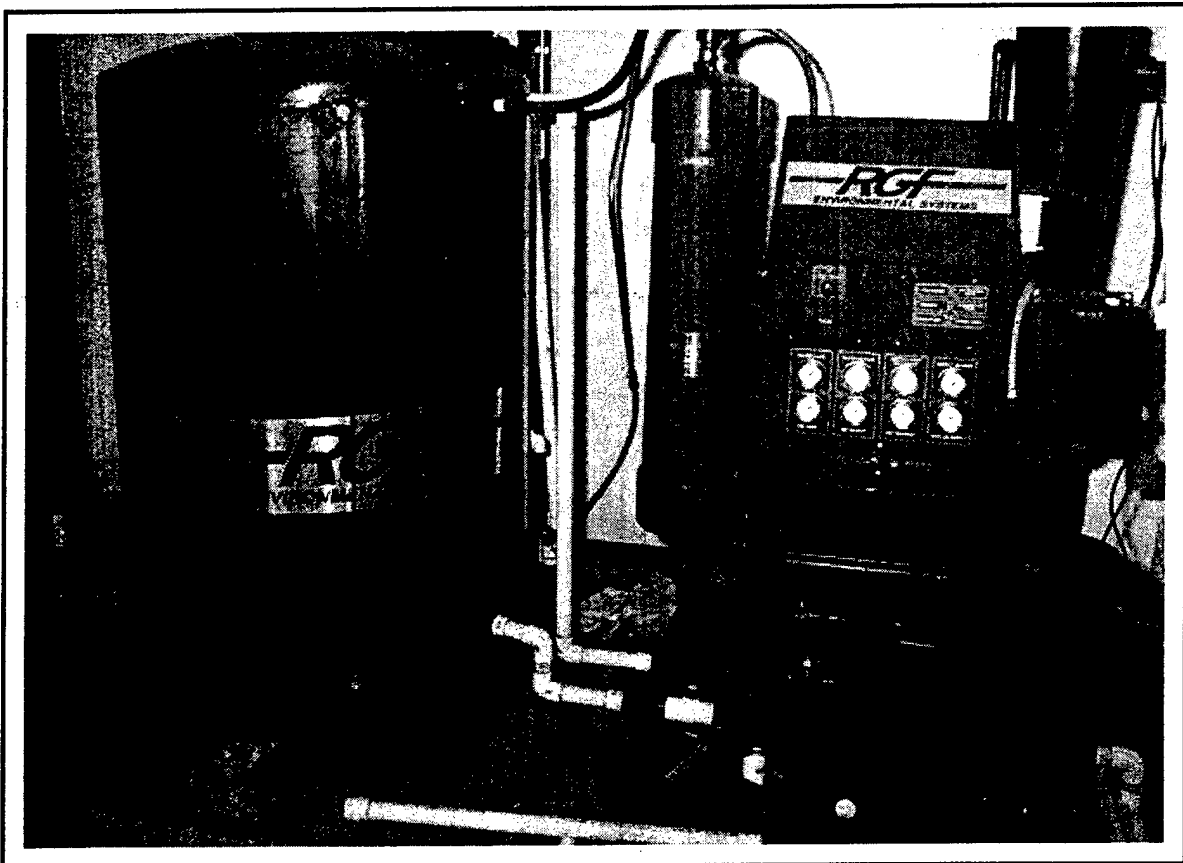
Figure 3. RGF system in Building 338 washrack, Aberdeen Test Center (Series I tank not shown).
